## Repair solutions for professionals

## Complete suspension arm fitting

BMW E 46: 316 i - 330 d (excl. 4x4) 02.98 - 02.07 BMW Z 4

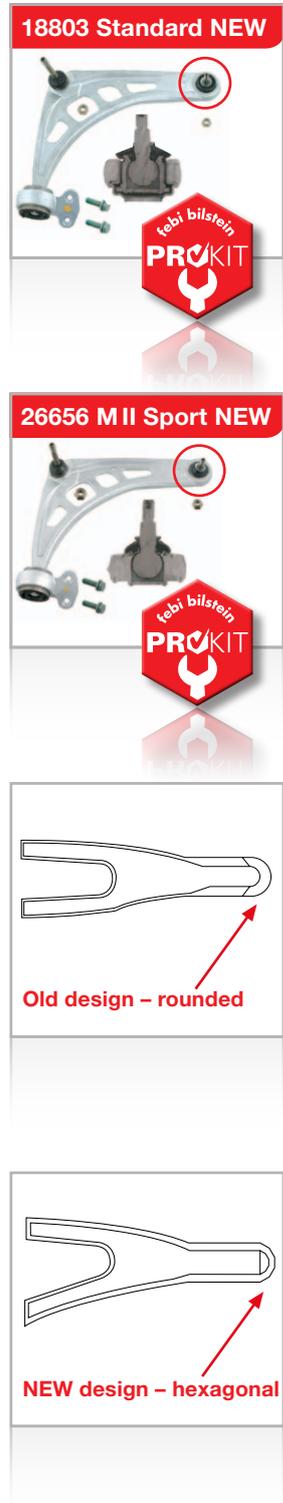
These suspension arms can only be distinguished by the design of the mounts (see cross section). The M II sports version can be identified by the round end, which extends product life, but reduces the driving comfort. The standard version is designed with a flat end.

**Caution:** In some vehicles you can still find the old versions of the suspension arms. They can be identified by the missing holes and the round mounts. According to BMW these suspension arms should be replaced by new versions. However, they must both be the same type. The suspension alignment must be checked after fitting.

Suspension arm rubber mountings must not be re-used, as the bushes get damaged during removal. We now include in our kits the bolts which must be tightened to 59Nm.

This means reduced fitting time and ensures that the rubber mountings are fitted in the correct position.
