NEW PRODUCT HIGHLIGHT | OCT2020

To Fit:
Various Volkswagen, Audi, Seat
and Škoda models

Engine: 1.8 and 2.0 FSi, TFSi

Oil Separator and Breather Hoses

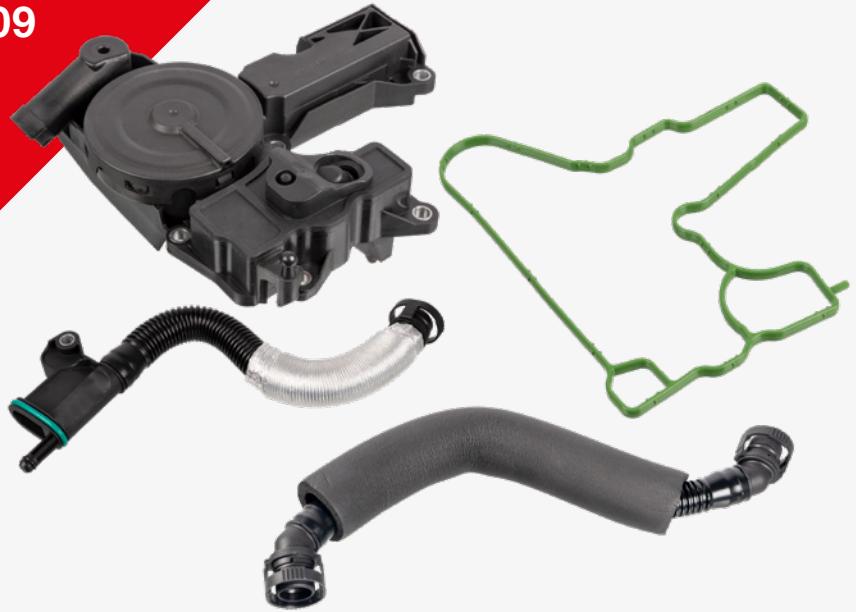
The pressure control and check valves, installed in the oil separator housing, regulates the suction as it separates the oil from the contaminated gases, according to engine speed, load and pressure ratio.

Over time, contamination causes reduced air flow and cracks can occur in the housing. Also, the sealing joints between the breather hoses can become dry and cannot seal.

The faulty oil separator or hoses cause the following symptoms: Engine idle speed fluctuation and stalling, whistling noises from the engine at idle speed, and an increase in oil consumption.

The oil separator and breather hoses are available separately or as a complete kit.
