febi 40135

Various Volkswagen, Audi, SEAT, Skoda & Ford models equipped with the 1.2, 1.4, 1.9, 2.0 & 5.0 TDI engines with unit injectors

Injector Nozzle Repair Kit

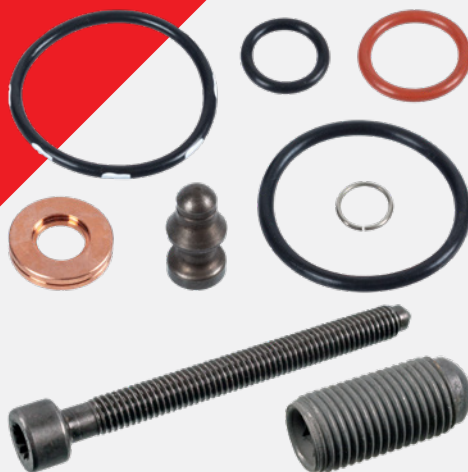
Engine is misfiring and performance is affected. Oil dilution, increased engine oil level.

The injector rocker arm is wrongly adjusted, causing the unit injector not to operate correctly.

Hardened 'O' ring injector seals, allowing fuel to mix with the engine oil.

Although new injectors come complete with new 'O' ring seals, both the heat insulating seal and the 'O' rings must be renewed if a unit injector is removed from the cylinder head and reused. The three 'O' rings and the heat shield seal, along with the securing clip, must be seated correctly when a new unit injector is installed.

When renewing the seals on an injector, carefully lever off the old 'O' rings, ensuring no burrs are left on the seating.

Always use assembly sleeves when fitting the 'O' rings to stop them twisting upon installation. Noting the correct position of each 'O' ring to the grooves, place it with the thickness reducing in the direction of the injector nozzle, then finish by fitting the new heat shield seal together with the securing clip.

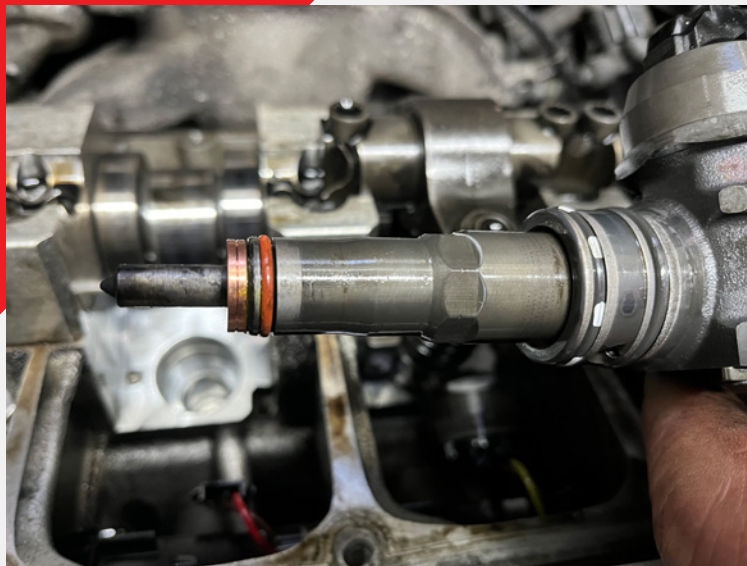
When maintenance is performed on these diesel engines, the unit injector has to be adjusted; and the adjustment screw in the rocker arm and the unit injector ball stud must also be renewed.

With very great care, install the injector seating into the cylinder head, and push the unit injector evenly into the cylinder head onto its limit stop. Then insert the tensioning block in the slot on the side of the unit injector and align.

Fit a dial gauge onto the adjustment screw of the unit injector and then check the injector rocker arm adjustment. Turn the crankshaft in the engine's direction of rotation until the roller of the rocker arm is positioned on the peak of the drive cam.

Note: the roller side must be positioned at the highest point, and the dial gauge positioned at the lowest point.

Remove the dial gauge and turn the adjuster screw into the rocker arm until significant resistance can be felt (unit injector is at the limit stop).

Turn the adjustment screw (225° 1.2 & 1.4) (180° 1.9, 2.0 & 5.0) back off the stop, hold the adjuster screw in this position, then tighten lock nut to 30 Nm.
