Audi, Seat, Skoda, Volkswagen, Mitsubishi, various models

1.9 & 2.0 TDi Engines

# Throttle Body

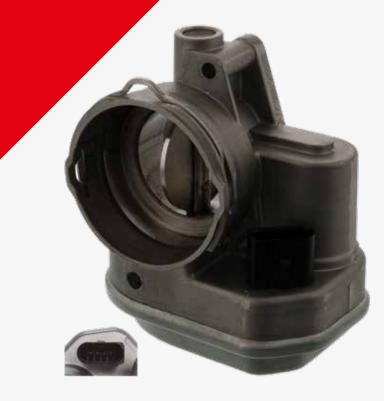
Engine management lamp illuminated, poor performance, increased engine temperature and/or engine shuddering during switch off. Fault codes logged relating to the throttle body, intake manifold flap and coolant fan motor.

The above symptoms can be caused by an excessive build-up of carbon deposits, failed throttle body drive components or a seized throttle plate. This results in a blown fuse which protects both the cooling fan and throttle body circuits.

Check and rectify all circuits relating to the faulty component and replace throttle body.
