Toyota Estima (Lucida/Emina) 2.2DT 1992 &gt; 1999

## Flexible Coupling Kit for Propshaft

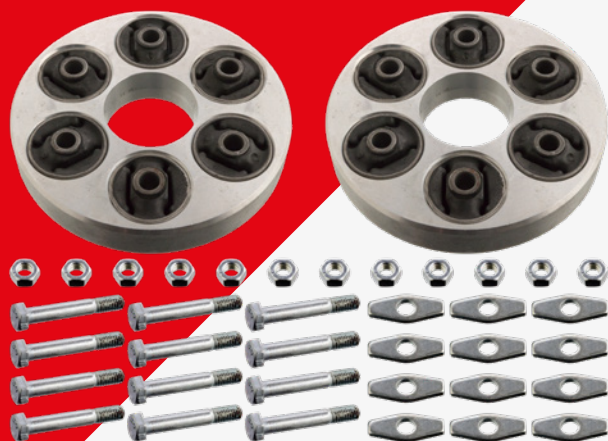
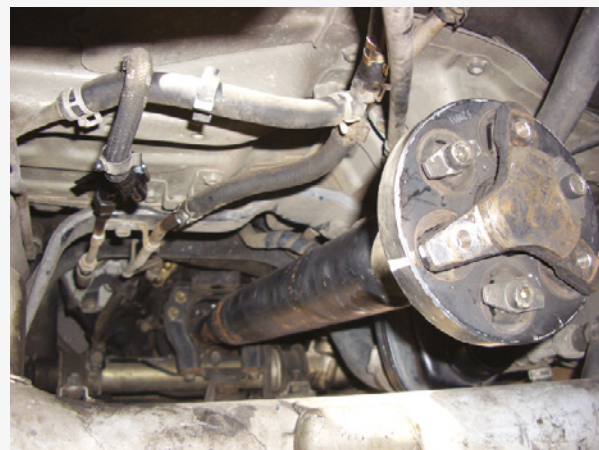
Figure 1

- Mark the shaft flanges prior to removal and refit them in the same position (this is to maintain the correct shaft balance).
- If possible, do not remove the 'Horse Shoe' shaped carrier assembly (fig 1), which may obscure access to the front coupling retaining bolts. This should be possible using an extension bar and socket while rotating the driveshaft to access one bolt at a time. The 'Horse Shoe' carrier position is factory set for optimal alignment. If removal is necessary, make sure to mark the original position beforehand.
- Remove any corrosion from the driveshaft flanges before refitting (especially the engine coupling).
