Audi A4, S4, RS4 (8K) Avant

## Rear wiper motor

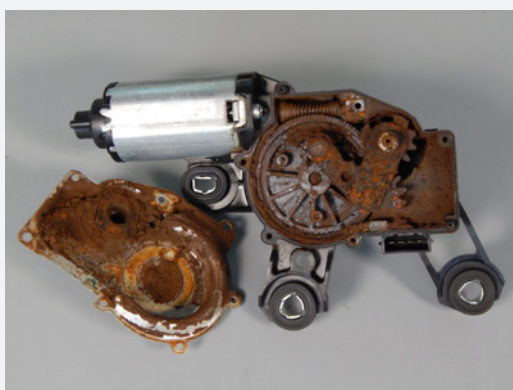
Figure 1

There is a blocked rear-washer nozzle or pipe. The washer fluid leaks internally into the wiper motor, corroding the internals of the motor mechanism. (Fig.1) Excess fluid leaks from the damaged wiper motor into the spare wheel area, affecting the battery and battery-control module and potentially causing multiple voltage-related faults with other control units.

Check and clean any excess water from the spare wheel area. Remove the rear wiper arm-cap, clean and check the washer nozzle for blockages, remove the rear wiper arm and remove the tailgate's inner-trim panel. Disconnect the washer fluid pipe and test its operation to check for blockages. Once satisfied that the rear-washer system is operating correctly, replace the rear wiper motor and clean any brown water stains from the affected trim and metal surfaces. Refit all other parts and test the rear wiper and washer operation.

Check the operation of any control modules that could have been affected by any water ingress and repair/replace as necessary.
