febi 179553

various Citroen, DS, and Peugeot models

Fuel filler cap for AdBlue® tank

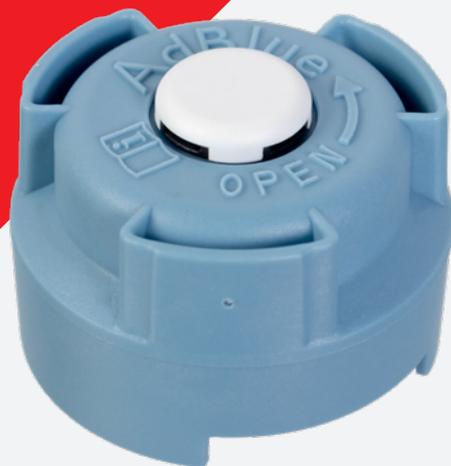
The engine management warning lamp and the fuel additive warning lamp are illuminated - with a message reading 'engine malfunction' displayed in the instrument cluster when the AdBlue® reservoir is sufficiently full.

This could indicate a failure of the AdBlue® reservoir or one of the components installed inside, which are not available separately

Before replacing the AdBlue® reservoir, check the condition of the filler cap for the reservoir, because the vent valve in the middle of the cap can become stuck due to a build-up of crystals. The crystals form when any overspill or splashes of AdBlue® evaporate, leaving crystal deposits. Replace the cap with febi part 179553, reset any fault codes from the control module, start the vehicle and take it for a test drive. After carrying out a road test, re-check the control module for any repeat fault codes to ensure the AdBlue® system is functioning correctly.
