febi 30076 30080, 34700

Mercedes Benz various models: 123, 124 (E-class), 201 (C-class), 460, 461, 463 (G-class), 601, 602, 611 (T1) with M102 engine

Thermostat Housing

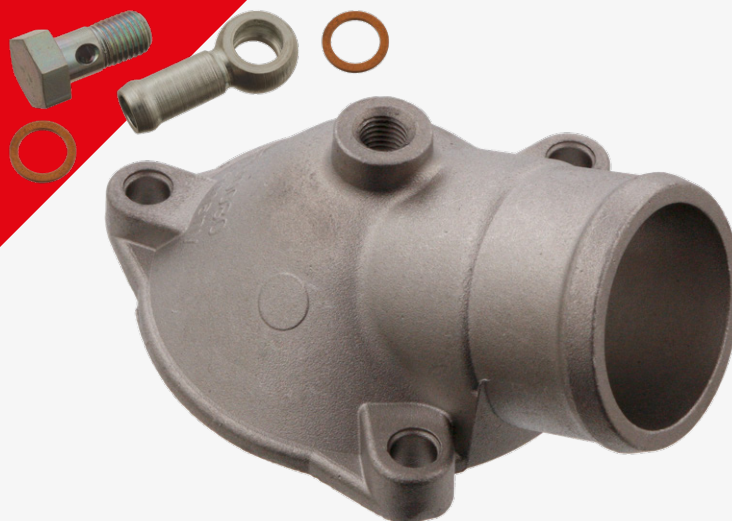
Coolant leaking from the plastic thermostat housing.

Continuous exposure to heat cycles and vibrations when the engine is operating; this can cause the housing to warp or fracture.

febi has developed an improved aluminium thermostat housing with connector, banjo bolt, and two sealing rings for a complete repair (febi 34700).
