febi 37000

All models of the Ford Focus 1
except for RS/ST170

Control arm including fitting materials

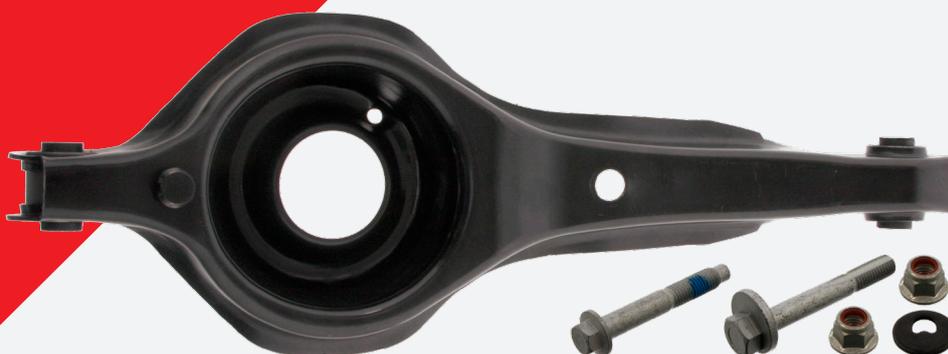
febi now also supplies these control arms as a ProKit with the appropriate nuts and bolts (febi no. 37000). This complete repair kit enables a professional repair without the need for additional sourcing trips. That saves time and money for both workshop and customer! Anyone using a ProKit can safely assume that it contains all the parts necessary for the repair.

The eccentric bolt and eccentric washer are used to set the camber which is absolutely imperative after replacing the control arm.
