febi 37681

BMW X5 E53 2000 - 2006

Bracket for door handle

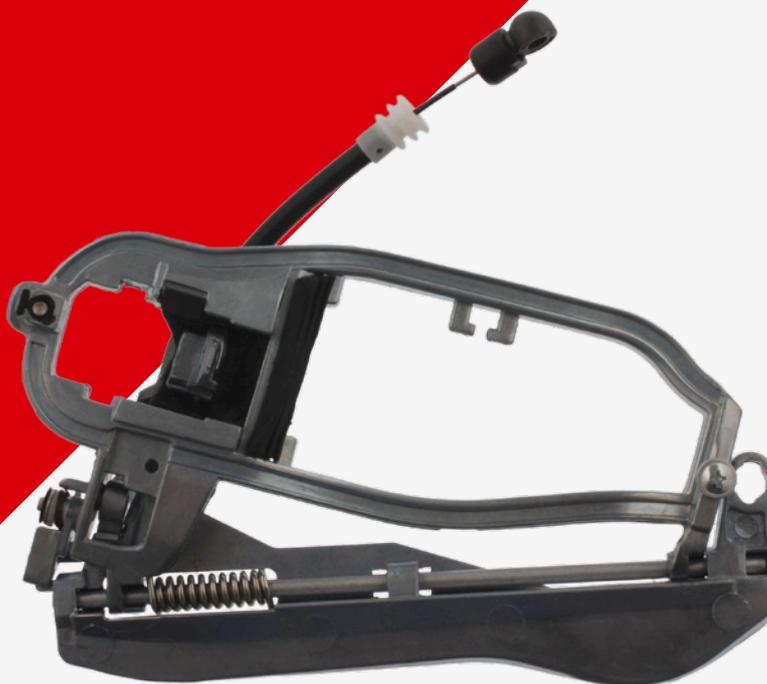
Unable to open the door, using the outside door release handle.

Over time, the Bowden cable stretches or breaks. The operating mechanism can also wear or break, therefore it is unable to operate the door latch.

Replace the faulty door handle bracket operating mechanism. Before removing any parts, disconnect the vehicle's battery to de-energise the airbag circuit. In order to gain access to this part, the interior door trim panel will need removing, be careful of any wiring loom connectors, that attach to the parts on the door trim panel. Then remove the airbag module. Ensure the module is stored in a safe place until required for reassembly.

Carefully remove the door panel membrane or replace it, if damaged. Remove the outer door handle lock and handle retaining screws and nuts. Remove the faulty part and replace with the new part, reassembling everything in reverse order. After all parts have been reassembled, reconnect the battery and carry out any component resets that are applicable, subject to the vehicle equipment.
