febi 39942

to fit:
all Chrysler 5-gear automatic transmissions

Conductor Plate Kit for automatic transmissions

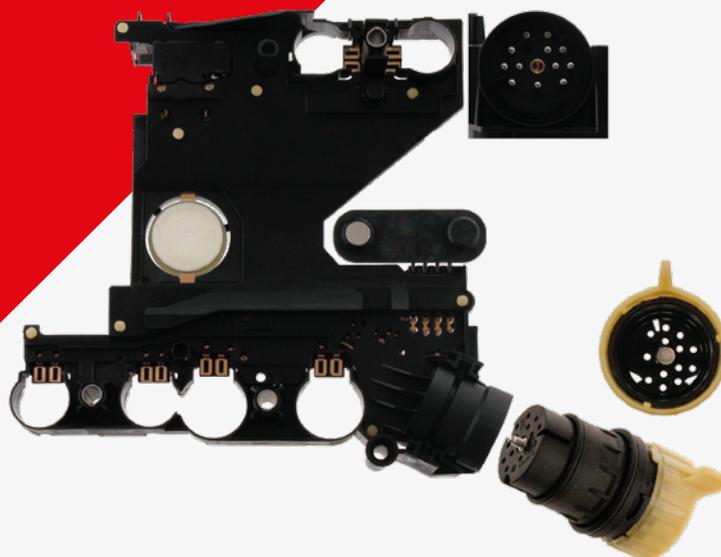
The sensors of the conductor plate stick together due to deposits in the automatic transmission fluid. This results in gear change malfunctions in the transmission.

Always replace the plug at the same time as replacing the conductor plate. Otherwise leaks may occur at the outlet from the conductor plate. As a result the oil perforates the seal and can therefore get into the automatic transmission control unit via the wiring loom and lead to damage in the control unit.

For this reason, febi supplies the complete kit febi 39942 which includes both the conductor plate febi 39482 and also the plug for automatic transmissions febi 36332. This combination enables a professional repair and avoids potential complaints. That saves time and money for both workshop and customer!
