**PLEASE FOLLOW FAE ASSEMBLY INSTRUCTIONS AND CHECK
CORRECT APPLICATION TO PREVENT ERRORS**

ASSEMBLY INSTRUCTIONS FAE 24760

ASSEMBLY INSTRUCTIONS FOR FAE REF. 24761/24762/24763

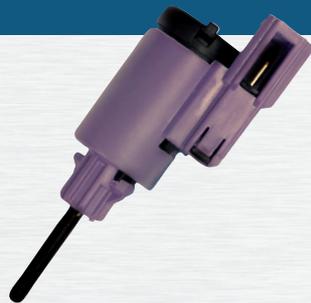
Ref. 24760

CONNECTOR: VIOLET Color / **BODY:** VIOLET Color / **PUSHER TYPE:** LONG

1J0 945 511 A
 1J0 945 511 B
 1J0 945 511 C
 1J0 945 511 D
 1J0 945 511 E
 1J0 945 511 F
 1J0 945 515
 8E0 945 515

This references are not replaceable each other.
