Service Info

Repair set 533 0118 10

for the tensioning unit in the assembly drive

Engine: 2.5 TDI

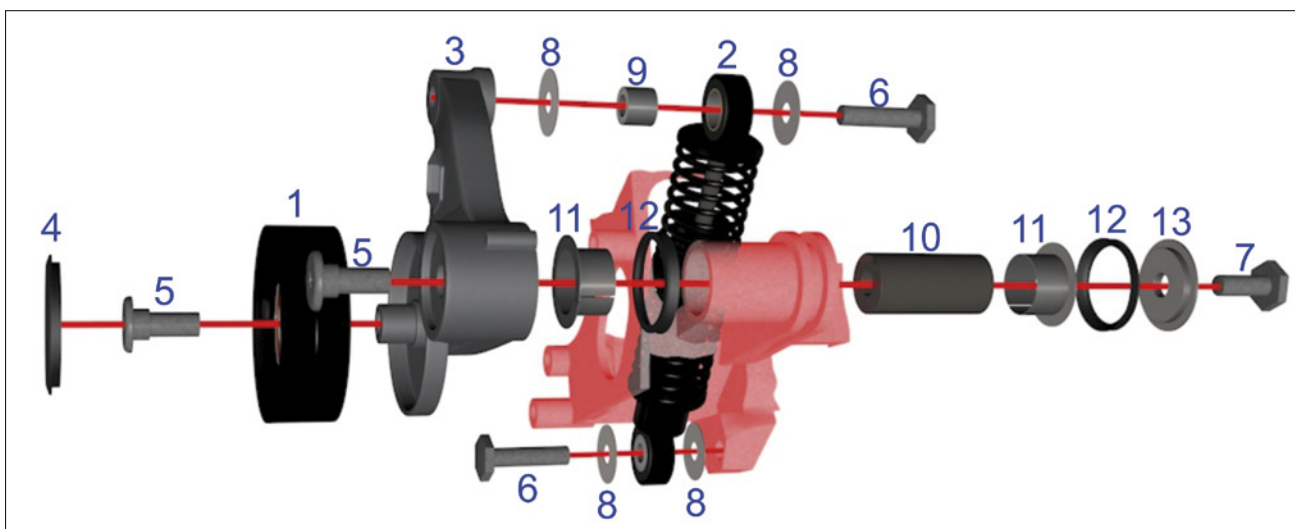
Image 3: 533 0118 10 – INA repair set for tensioning unit

Contents of repair set 533 0118 10:

1	Tensioner pulley	531 0751 30	9	Sleeve \varnothing 8,2x12*
2	Damper	533 0112 10	10	Pin M8x18x40*
3	Holder	533 0115 10*	11	Friction bearing \varnothing 18x20x12*
4	Protective cap*		12	Seal \varnothing 26 x 33 x 6
5	Fit bolt M8x10x25*		13	Washer \varnothing 8,2x16*
6	Bolt M8x32*			
7	Bolt M8x20*			
8	Washer \varnothing 8,2x24x1*

With this in mind, Schaeffler Automotive Aftermarket is offering a complete repair set (Page 2/ Image 3) for the vehicles specified above.
