# Blue Print ADM59860

to fit:  
Mazda RX8

## Mazda RX8 – Expansion Tank Coolant Level

### Mazda RX8 coolant light on when level is correct?

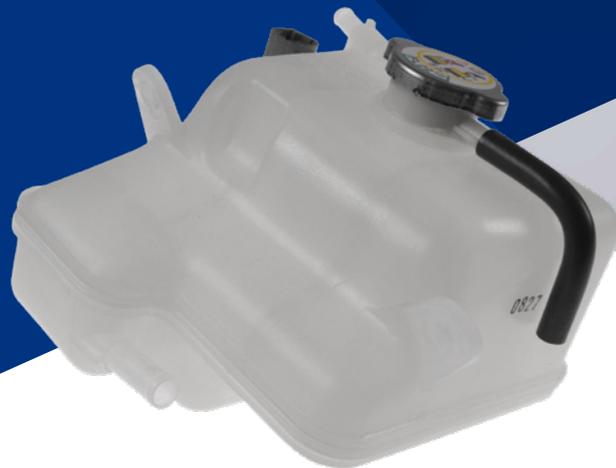
The coolant level sensor float is a common failing part on the Mazda RX8.

This is caused by surface deterioration of the sensor float which allows it to absorb coolant, causing the float to sink and give a false reading.

The coolant level light on the dashboard either stays on or flashes indicating a low coolant level, even when the coolant level is actually correct.

The sensor and float are not available separately, meaning the only permanent repair is to replace the complete Expansion Tank assembly.

Blue Print now supplies an OEM quality **Expansion Tank** with a revised specification coolant level sensor float – **ADM59860** – which is covered by Blue Print's comprehensive Three Year Warranty.

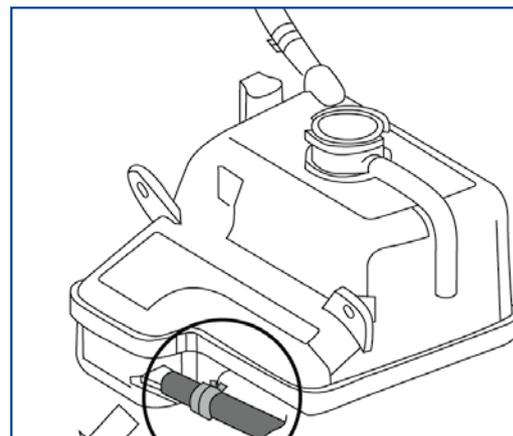
**Note:** Care is required when removing the coolant hose shown in the picture below, in order to avoid damage to the outlet on the radiator.
