**Confronto tra PA 24-0724A/PA0724A/10724A nuova e vecchia versione**

**Comparison between WP 24-0724A/PA0724A/10724A new and old version**

Nell'immagine qui sotto vengono evidenziate le principali differenze tra le due pompe acqua Metelli a seguito di allineamento a nuova versione del campione originale.

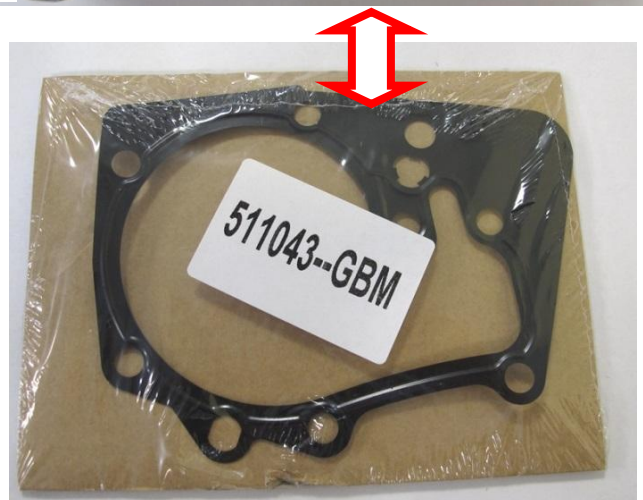
**Fig.1A-1B:** nella vecchia versione, il piano di fissaggio presenta delle scanalature per l'applicazione della pasta sigillante, in fatti, la vecchia versione della PA 24-0724A non era fornita con guarnizione e la pompa acqua si doveva montare con pasta sigillante. La nuova versione invece ha il piano di fissaggio completamente liscio perché fornita con guarnizione.

*The pump fixing plane of the old version shows some grooves for the sealant application, in fact, the old version of the WP 24-0724A was not supplied with gasket and the water pump had to be fitted with sealant. The new version instead has the fixing plane completely smooth because it is supplied with gasket.*
